### Tiling — Cracked tiles on wood

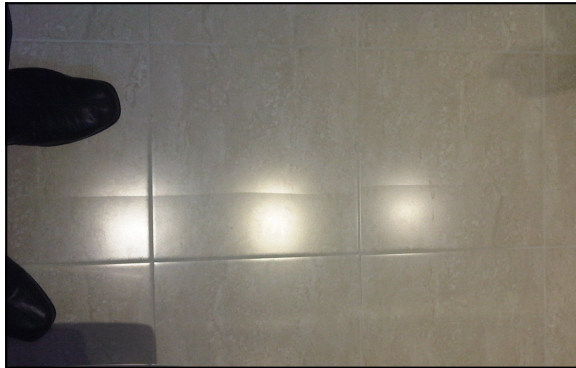
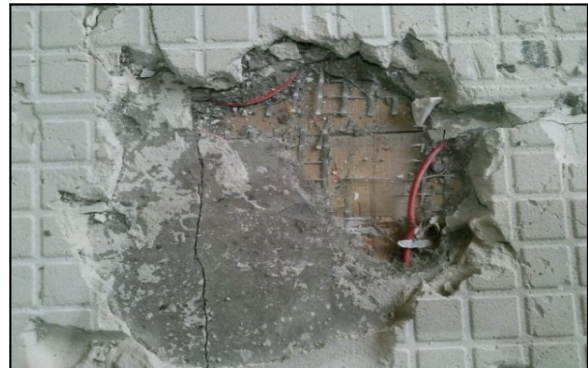
Tiles are cracked but are normally well adhered to the wooden substrate. The cracks are often in straight lines and if a tile is lifted, will follow board joints. Quite often a noticeable 'bounce' will be felt in the floor as it is walked upon.

The cracking is caused by excessive deflection in the floor. If cracking is localised, it is most likely due to an unsupported board joint.

The floor needs to be reinforced to reduce deflection. The tiles and wooden boards should be removed and the floor stiffened as appropriate. A minimum of 18mm WBP plywood should be screwed to joists at 200-300mm intervals and all board joints supported by noggins. If there is still noticeable deflection in the floor, another layer of plywood or suitable tile backer board should be used. For extra reassurance a two-part adhesive such as **weber.set rapid plus** and **weber AD250** should be used to fix the tiles.

An alternative solution when tiles and boards are difficult to remove, and the floor height allows, is to prime with **weber PR360** and overlay with a minimum 10mm of **weber.floor flex** leveling compound. Once hardened, a two-part adhesive such as **weber.set rapid plus** and **weber AD250** should be used to fix the tiles.
