### Tiling — De-bonding on Anhydrite Screeds

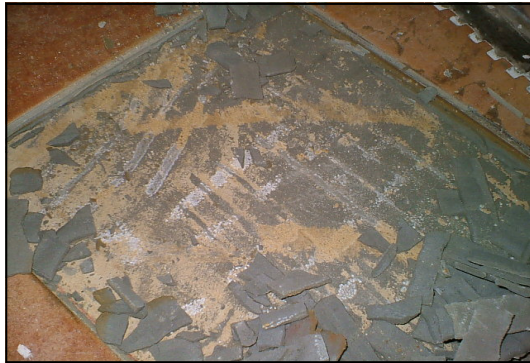
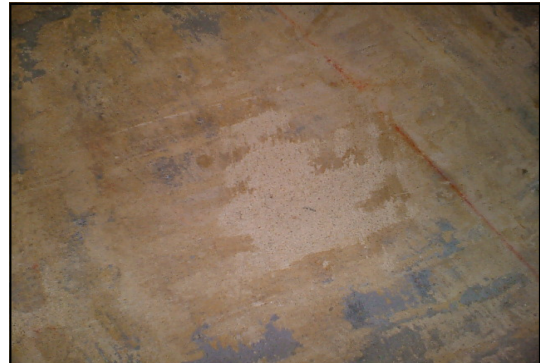
The adhesive will come away from the substrate and often a layer of laitance will still be adhered to the adhesive. In extreme cases the adhesive will become very crumbly.

Failure in removing the weak layer of laitance that forms on the surface of the screed.

Insufficient priming between the cement-based product and the calcium sulphate based screed. When cement and calcium sulphate come into contact with each other a mineral called ettringite forms. This mineral is particularly weak and can cause a failure to occur at the interface between the screed and adhesive. In extreme cases the mineral can grow within the adhesive matrix and cause it to become weak and crumbly.

All tiles should be removed. If the laitance on the screed has not been removed, this should be sanded away. The screed should be thoroughly primed with **weber PR360** and allowed to dry. Once dry a second coat should be applied at 90° to the first and allowed to dry. The tiles should now be fixed using **weber.set rapid SPF** or similar suitable **Weber** adhesive.
