Tiling — Dot and dab incorrect application

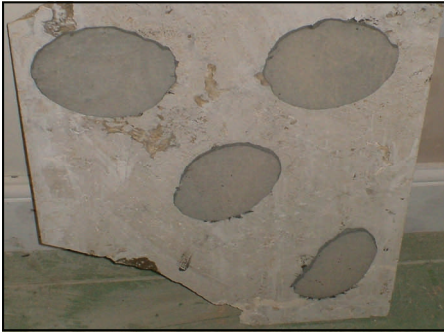
Figure 1 – The tile backs and substrate will have four or five rounded columns of adhesive with substantial air voids in between.

This is caused by using an incorrect application technique. Often tilers will use the dot and dab technique to get tile levels correct by building mounts of adhesive and tapping down until level. This leaves only small areas of the tiles and substrate in contact with the adhesive and leaves large air voids.

Often it is difficult to remove the tile and adhesive without damaging the substrate.

A time and cost effective solution for floors is to remove the tiles and loose adhesive, prime with **weber PR360** and then cover with **weber.floor flex** leveling compound (10mm minimum on wooden substrates). The tiles can then be re-fixed using the correct application technique to ensure 100% coverage.

For walls it is often quicker to remove and replace the boards and then re-fix using the correct application technique.

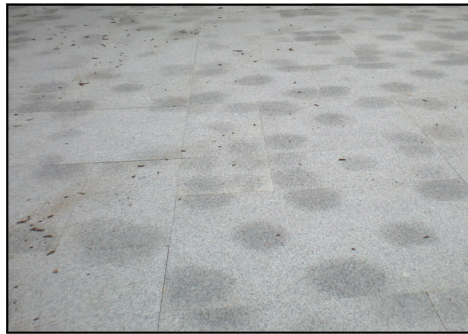
Figure 2 – Spots of adhesive can be seen through the tile.

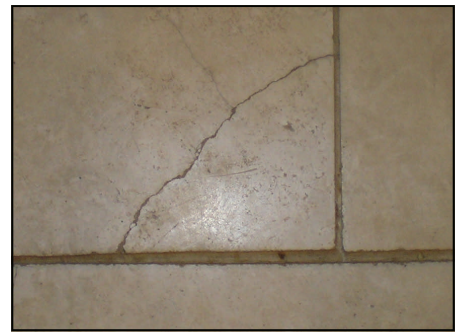
Figure 3 – Tiles crack in areas that are unsupported due to point loads such as heels or furniture.
